HOME INSPECTION

1234 Main St.
Seattle, WA 98188

January 2, 2013

Date of Inspection: January 1, 2013
Engineer: Dave Pioli, P.E., Licensed Home Inspector
Home Inspector License Number: 203

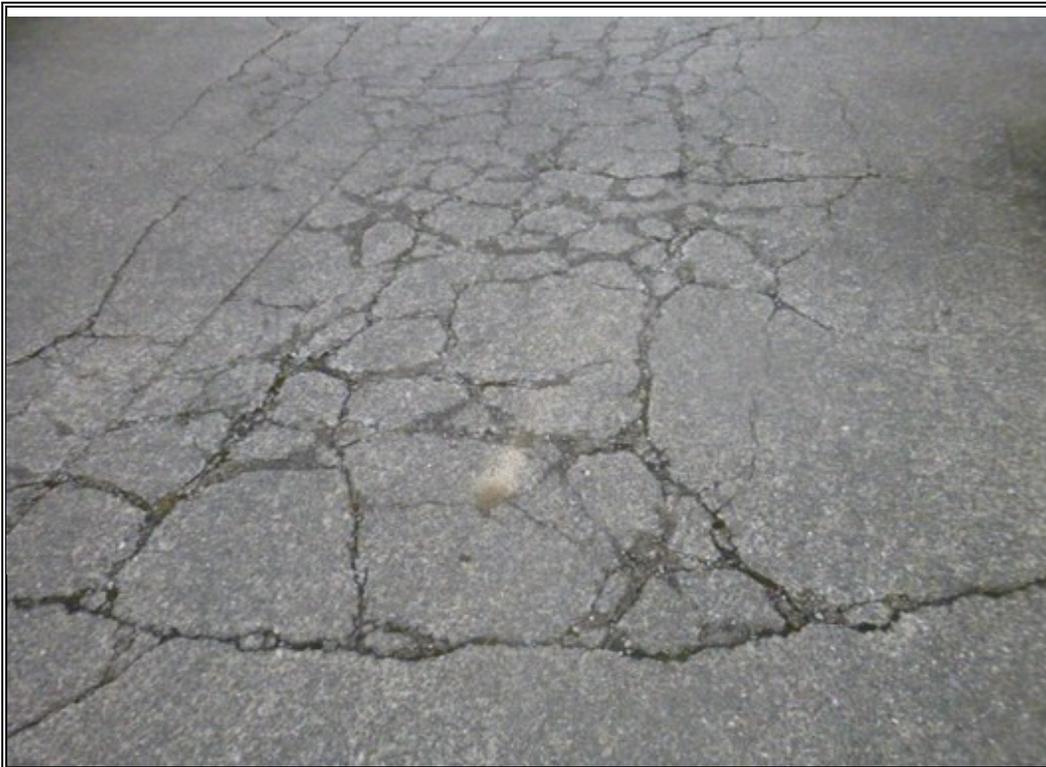
Photo Number
2

Description:
Cracking and
distress in concrete
driveway access

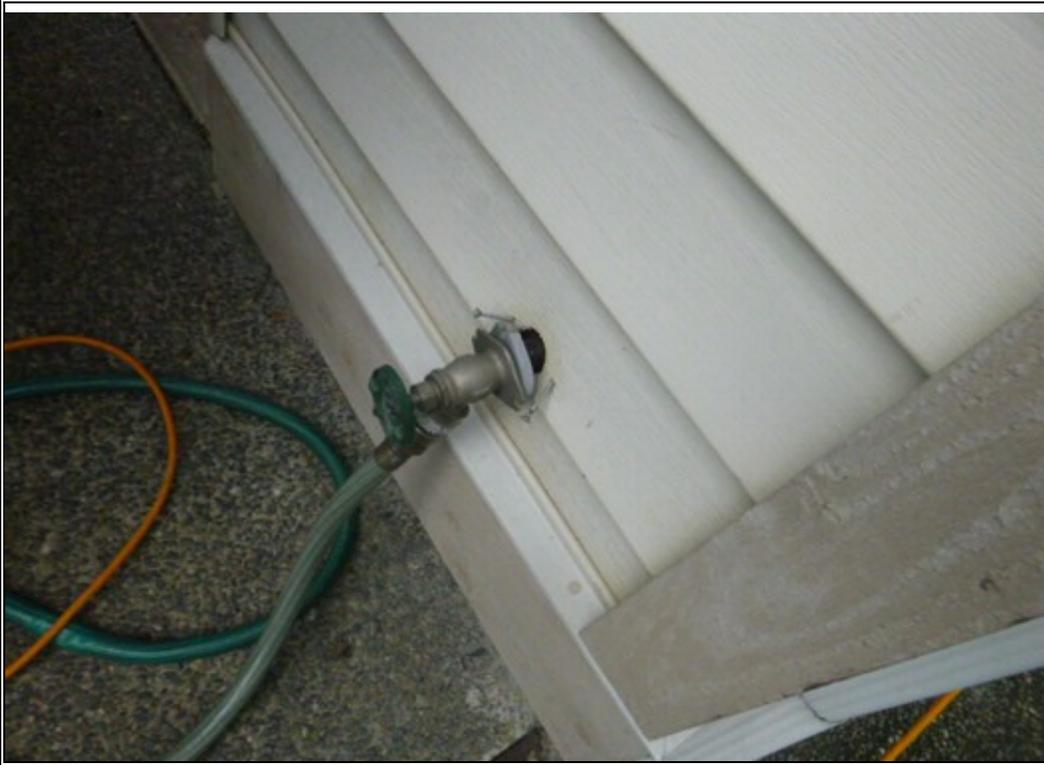
Photo Number
3

Description:
Poor mounting and
sealing of water
spigot at front

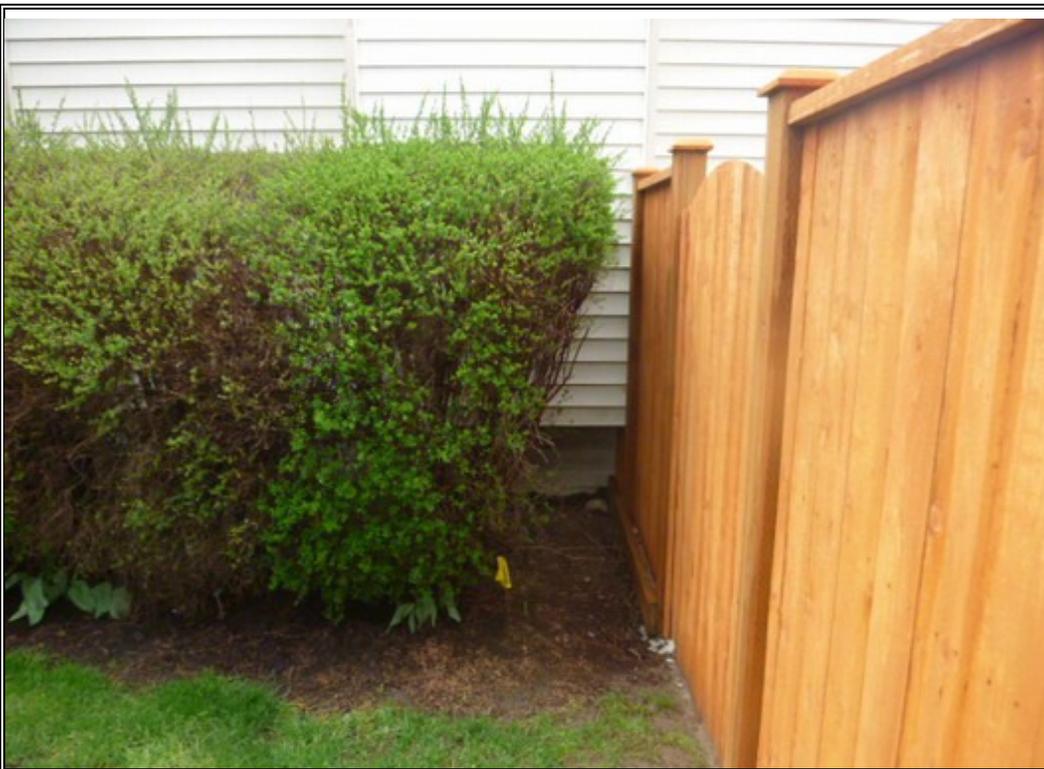
Photo Number
4

Some of the siding is close or touching the ground. As a result, splashback (during rainstorms) and upward migration of water from the adjacent ground will lead to rot and deterioration. We recommend re-grading to eliminate the earth/wood contact.

Description:
Earth siding
contact at entrance
side

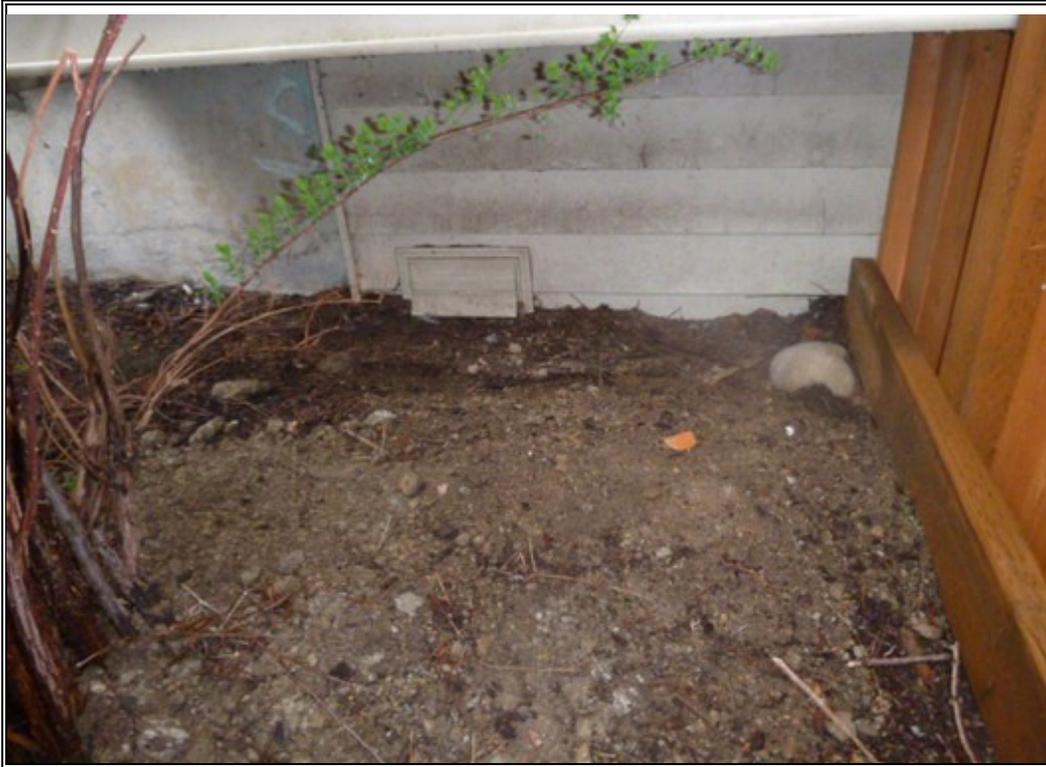
Photo Number
5

Description:
Earth siding
contact at entrance
side

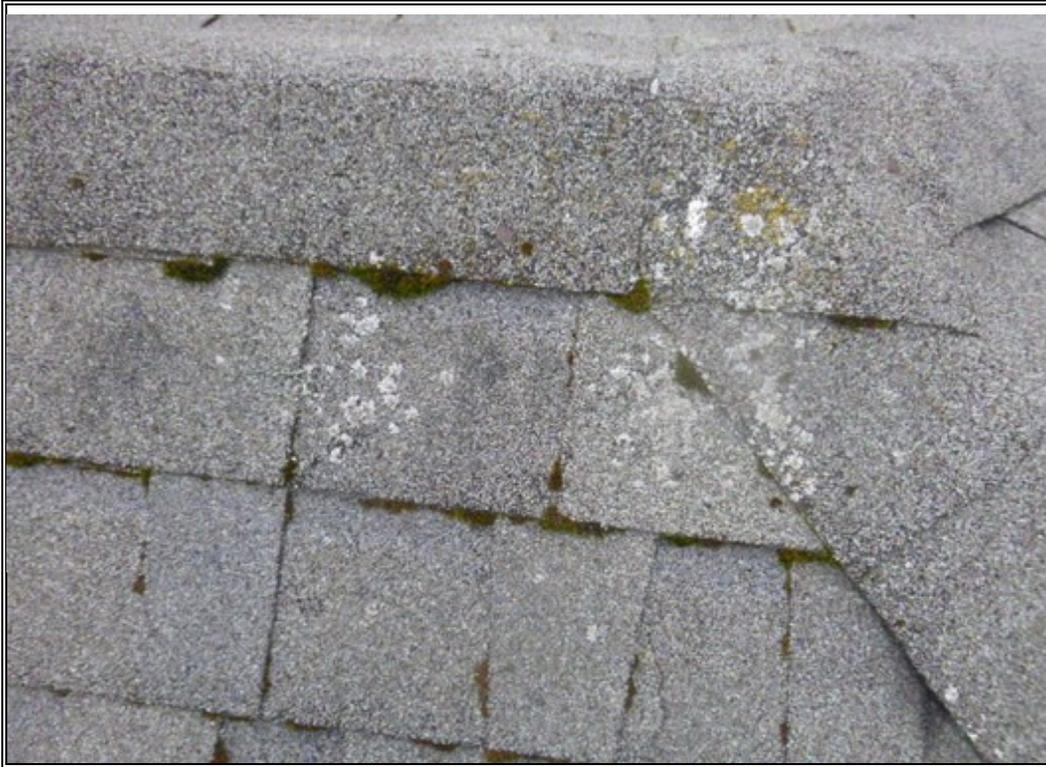
Photo Number
9

The roof was examined directly by going onto the roof. The roofing is in good condition with an estimated remaining useful life of 7 years.

Description:
Wear in roof

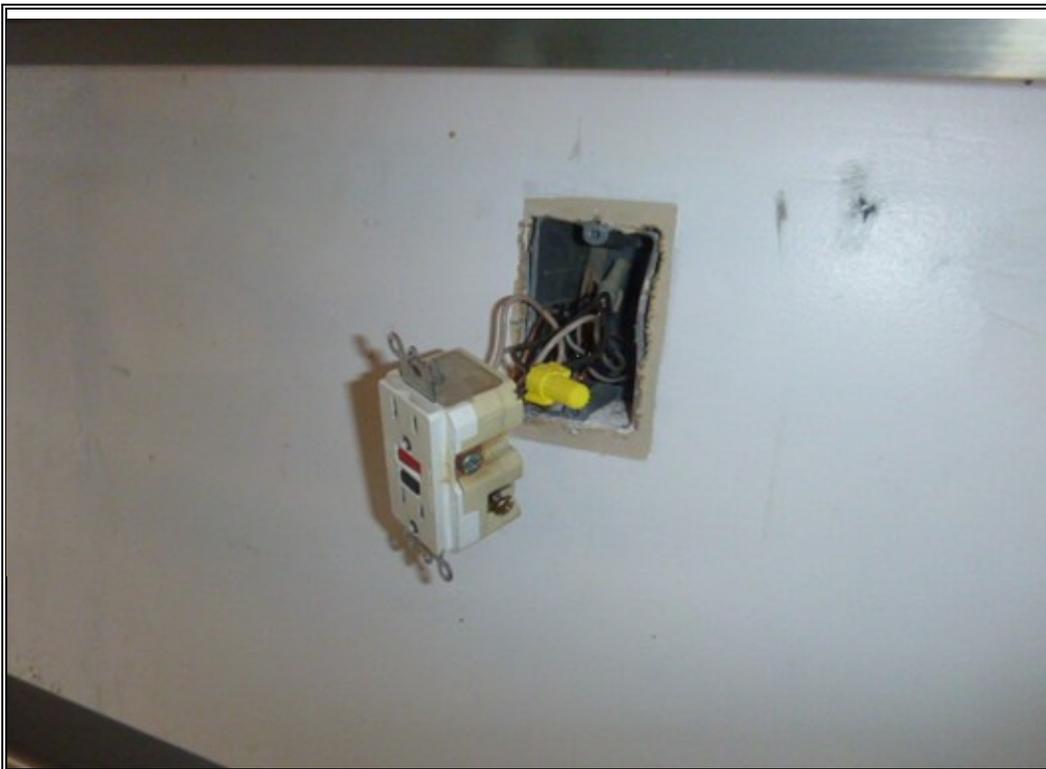
Photo Number
12

Ground fault circuit interrupters (GFCIs) are recommended for the exterior outlets. Additionally, repairs are needed to the GFCI outlet in the garage. This poor condition of the outlet may explain the lack of power at the rear. Repairs are needed.

Description:
Poor outlet in
garage

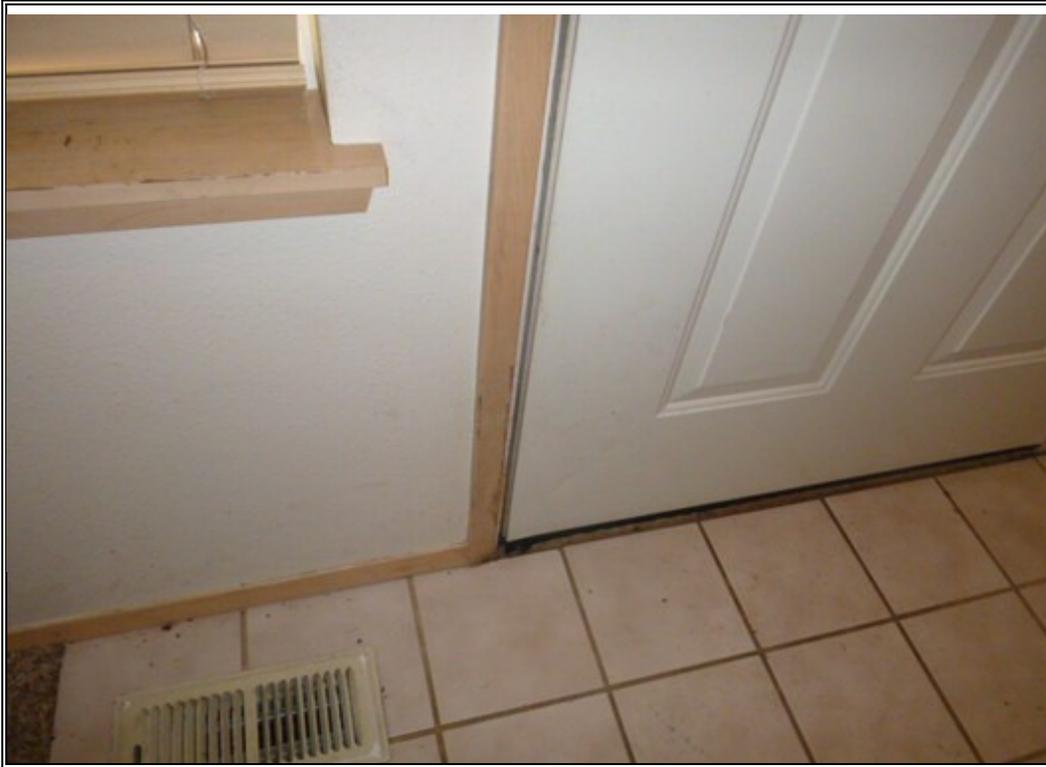
Photo Number
13

The weather-stripping was poor at the front door. As we discussed, this door has some previous damage and the door is questionable and you should consider removal and replacement of the entire unit.

Description:
Poor weather-
stripping and
damage to front
door area.

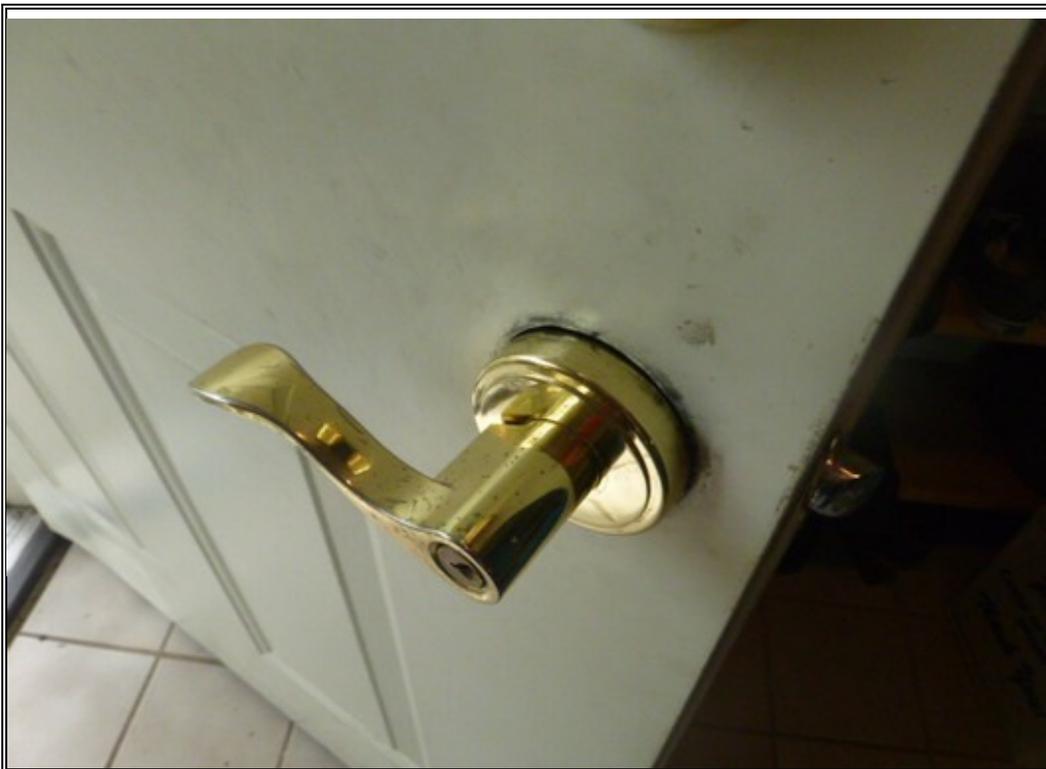
Photo Number
14

Description:
Damage to front
door and marginal
installation of
handle.

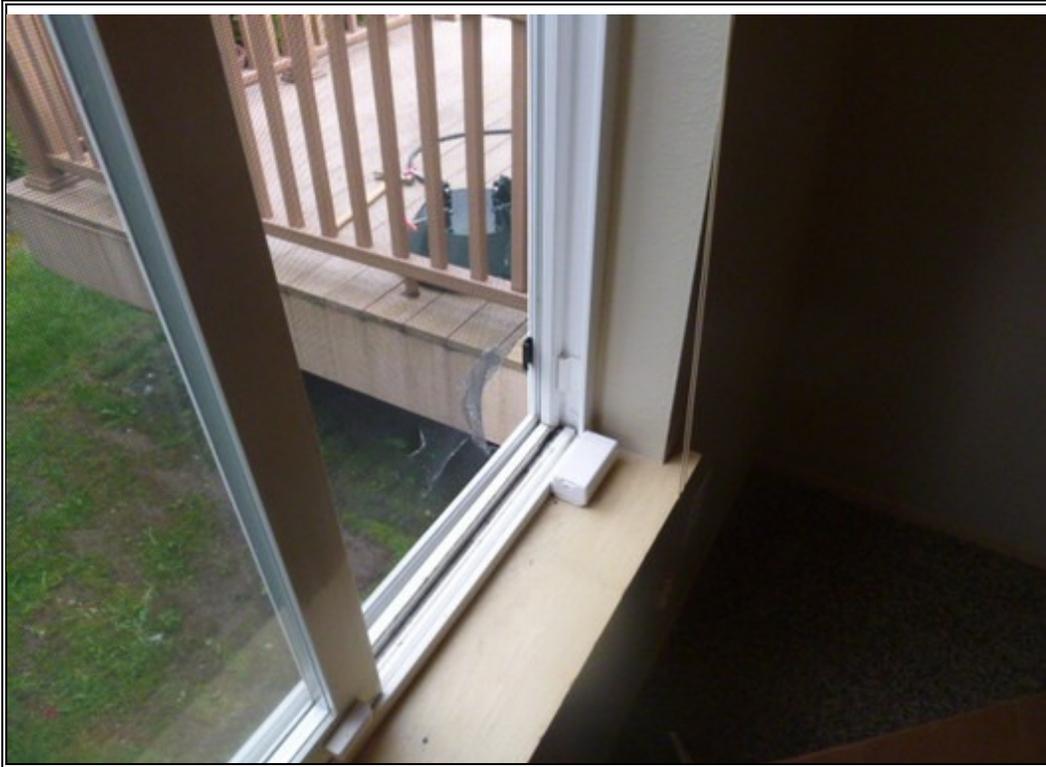
Photo Number
15

As discussed in "INTERIOR," many of the window screens are either damaged or missing.

Description:
Damaged screen

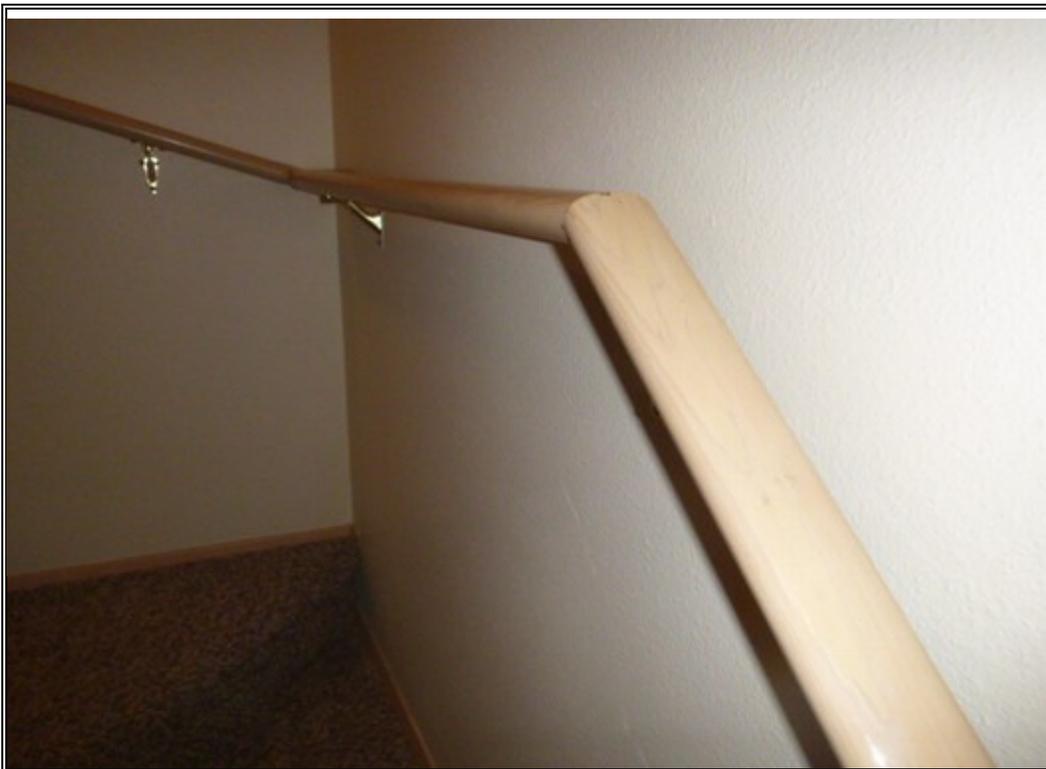
Photo Number
16

The handrail is missing to the upper level. Repairs are needed.

Description:
Handrail is loose

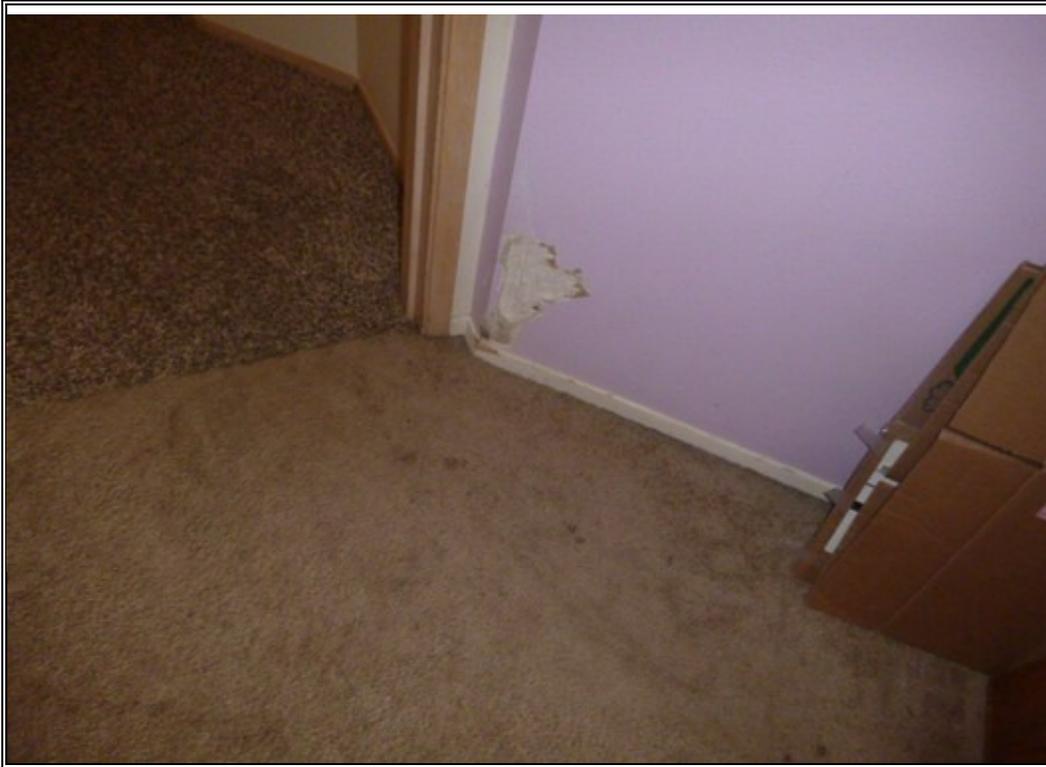
17

Damage to carpet, wallboard, and trim at upper level

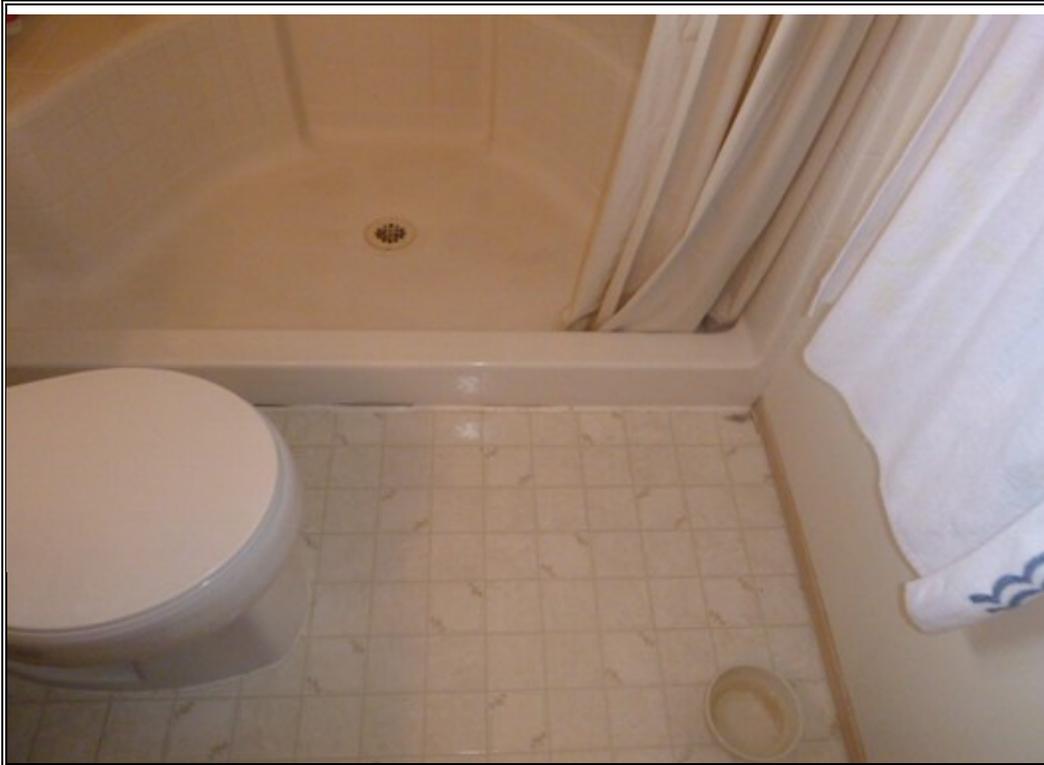
19

Poor caulking and water seepage under vinyl flooring

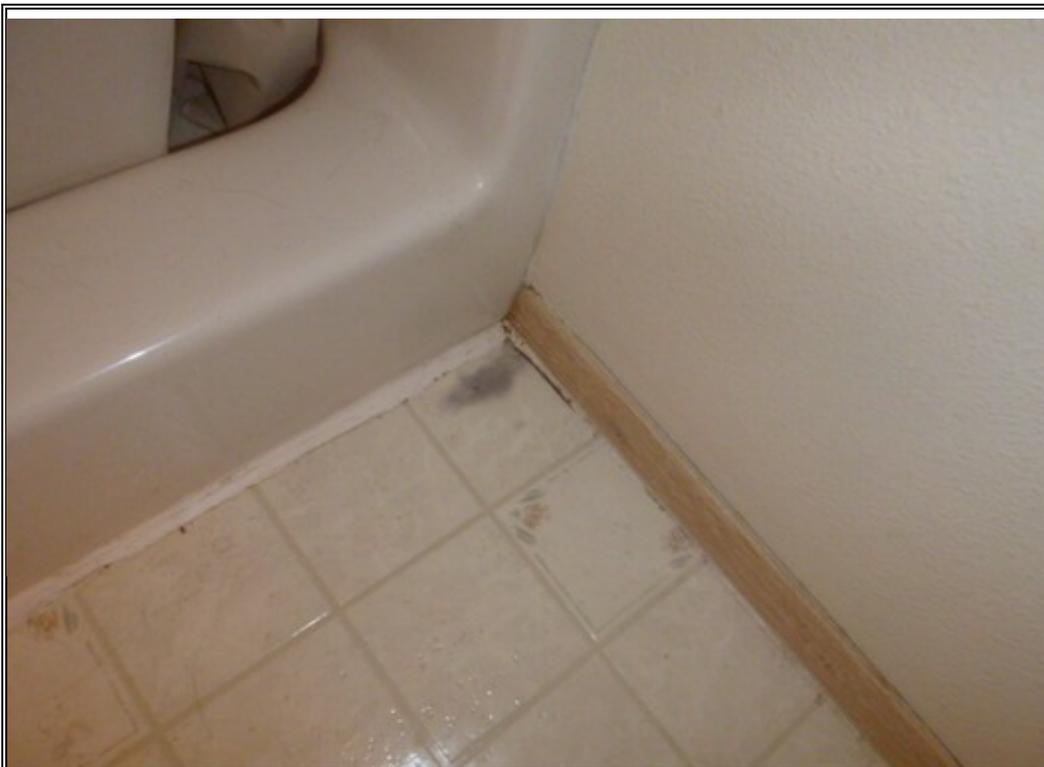
20

Poor caulking and water seepage under vinyl flooring

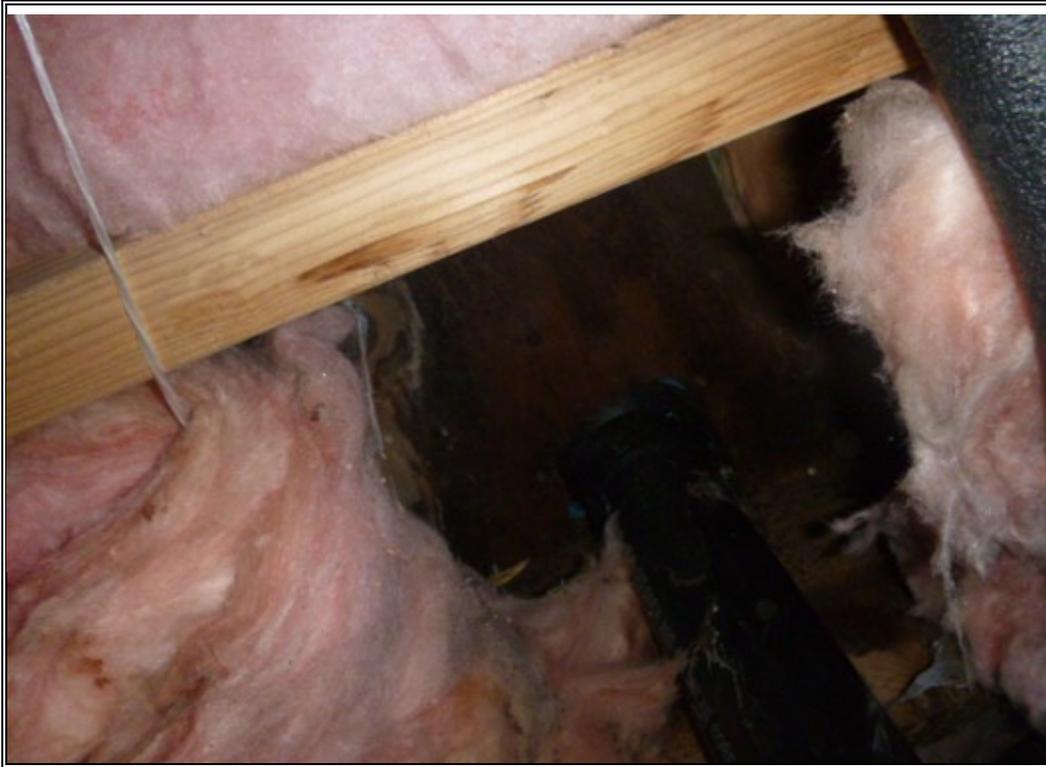
Photo Number
23

There is an obvious plumbing leak visible in the crawlspace around the toilet from the main floor powder room. Repairs are needed.

Description:
Water leak at toilet
in crawlspace

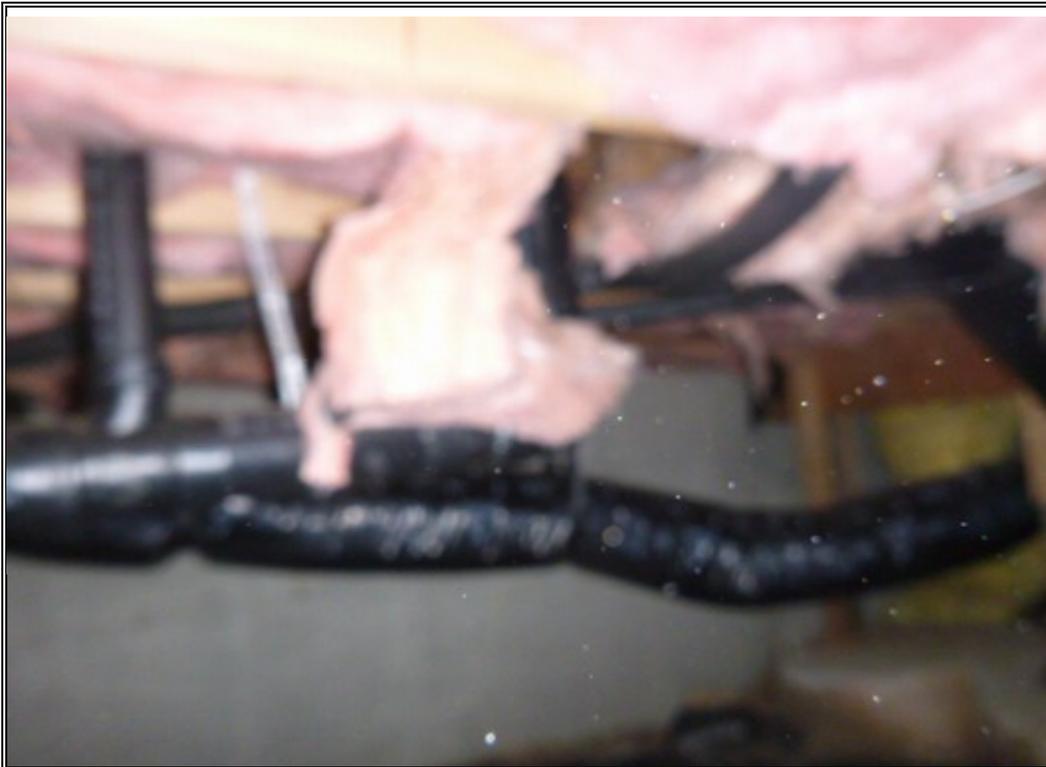
Photo Number
24

Description:
Water leak at toilet
in crawlspace

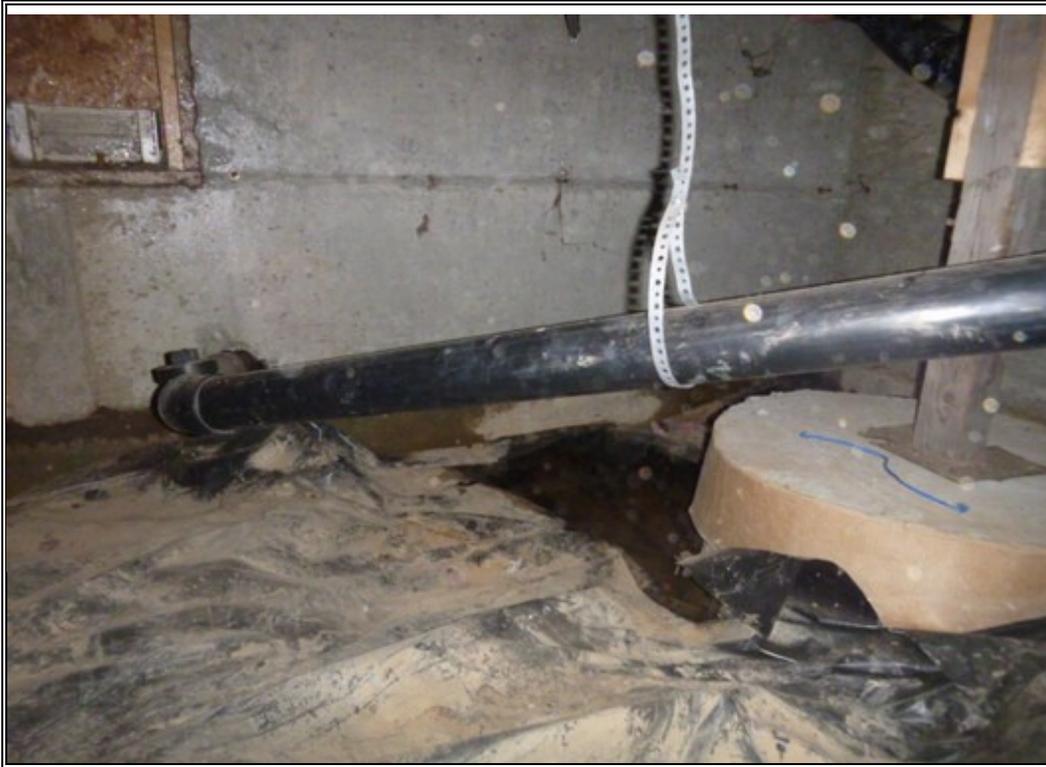
Photo Number
25

There was standing water on approximately 5% of the crawlspace floor. This exists in the vicinity of where the sewer pipe penetrates the foundation. It appears that some water has seeped around the space between the sewer pipe and the concrete wall. Sealing this gap may somewhat reduce standing water.

Description:
Standing water and
water seepage at
pipe penetration in
crawlspace

One way to address standing water in the crawlspace is to raise the floor of the crawlspace with gravel. This consists of removing the vapor barrier and any debris and importing enough pea gravel or other free draining gravel to above the level of past standing water. The vapor barrier would then be re-installed. In this way all the standing water is contained below the level of the vapor barrier. If standing water cannot be controlled via these measures, then the installation of a sump pump in the crawlspace is recommended. It may be necessary to regrade a small portion of the crawlspace floor to allow the area to drain to the sump and/or installation of a French drain type system.

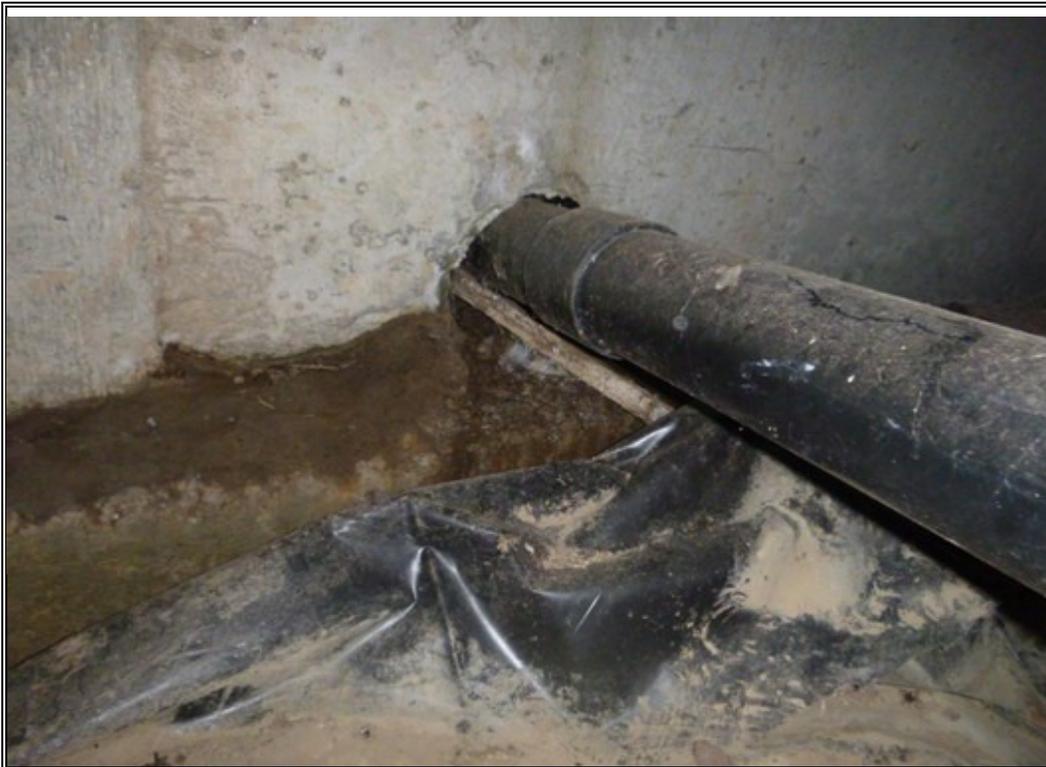
Photo Number
26

Description:
water seepage at
pipe penetration in
crawlspace at
sewer pipe

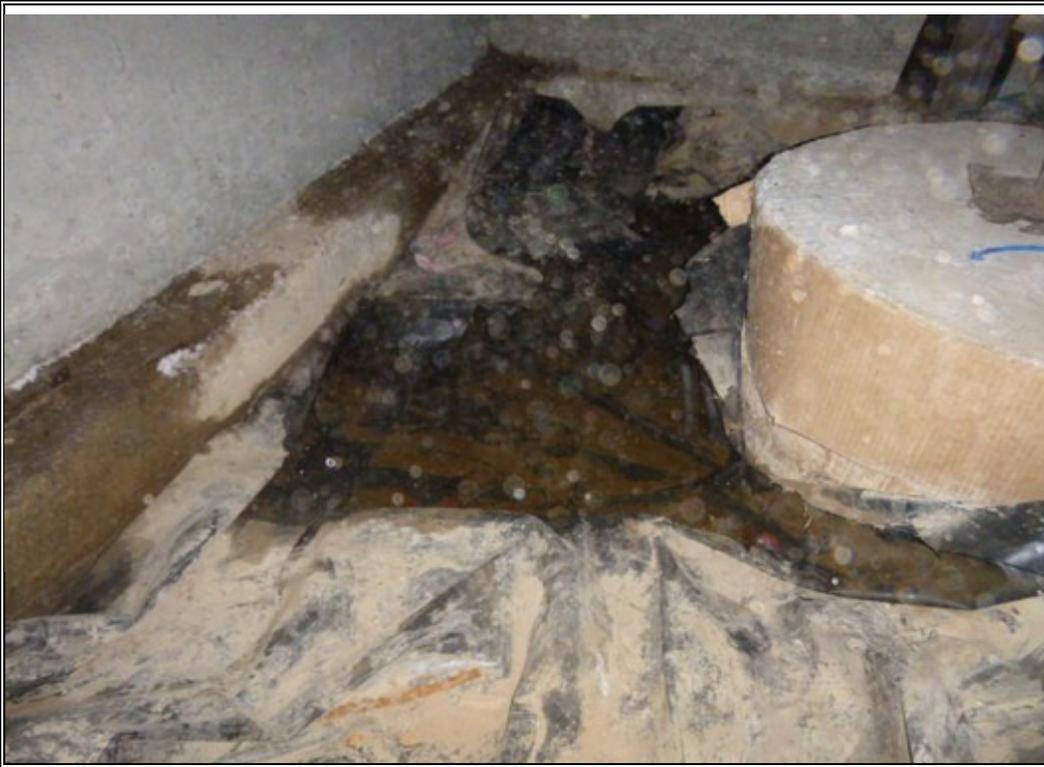
Photo Number
27

Description:
Standing water and
water seepage at
pipe penetration in
crawlspace

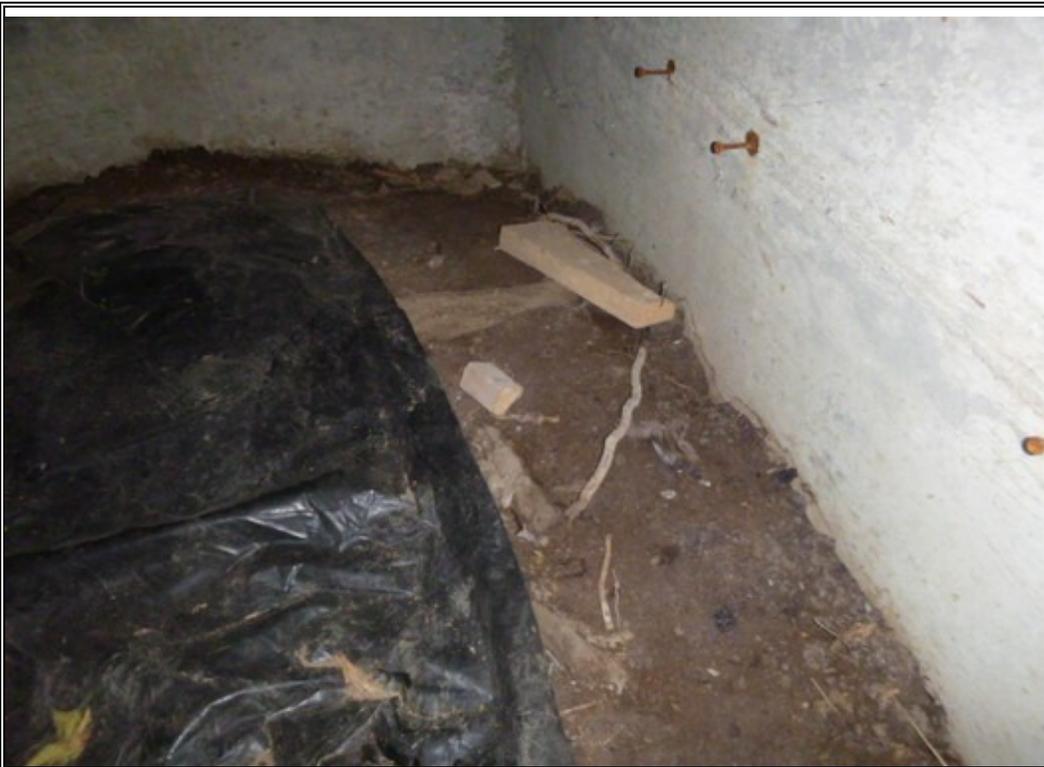
Photo Number
28

The entire dirt floor of the crawlspace was mostly covered with a vapor barrier material (polyethylene is commonly used) to help keep the humidity level low and dampness out of the wood framing. The floor of this crawlspace was only partially covered with a vapor barrier. We suggest covering the entire dirt surface. Rocks, bricks or chunks of concrete can be used to hold the vapor barrier in place. Wood should never be used as it can promote rot and wood-destroying-insect infestation.

There is some wood and cellulose debris on the crawlspace floor. This material tends to retain moisture, restrict ventilation and is a habitat for wood destroying organisms and should be removed.

Description:
Poor vapor barrier
and wood debris
